Field Trip Guide to Selected Locations Along the Baton Rouge Fault Trace
Spanning the Pleistocene–Holocene Transition in Western East Baton Rouge Parish

Richard P. McCulloh
Louisiana Geological Survey

Louisiana Geological Survey
Baton Rouge, Louisiana State University

2008

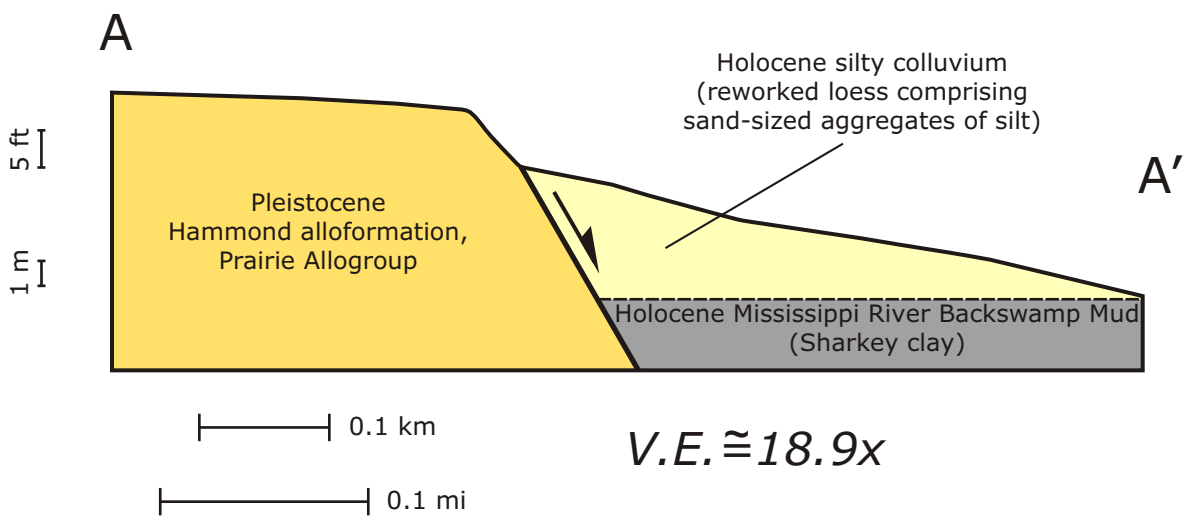
Figure 5. Map of area encompassing *Stop 2*, traced from portion of U.S. Geological Survey topographic map sheet for Baton Rouge West 7.5-minute quadrangle (modified from McCulloh, 1996, LGS Open-File Series No. 96-01, Figure 4), and interpretive cross section A-A'.

Figures 4 and 5 (modified from McCulloh, 1996) show the location of Stop 2 on an index map of faults in East Baton Rouge Parish, and a map and interpretive cross section (**A–A'**) showing the distribution of colluvium in this area and its geomorphic expression.

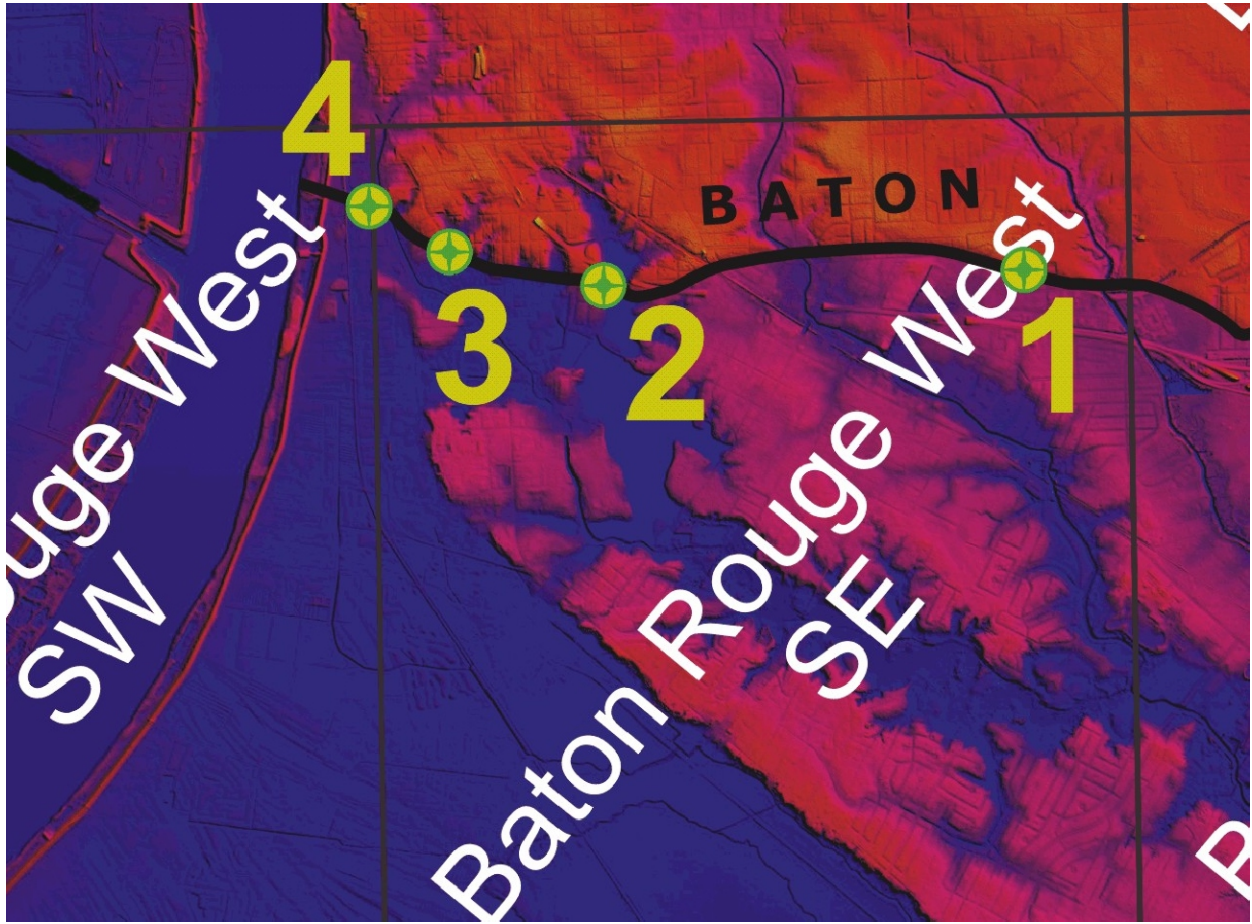
Figure 6. Excerpts from figures 1 and 2 to show *Stops 3 and 4* in greater detail.

Figure 6 consists of zoomed excerpts from the two front index maps, to show the areas of Stops 3 and 4 in greater detail; Figure 7 is a photo (from McCulloh, 2001) of the Stop 3 area in a view looking north-northwest (the line of red dots marks the approximate fault trace on the road).

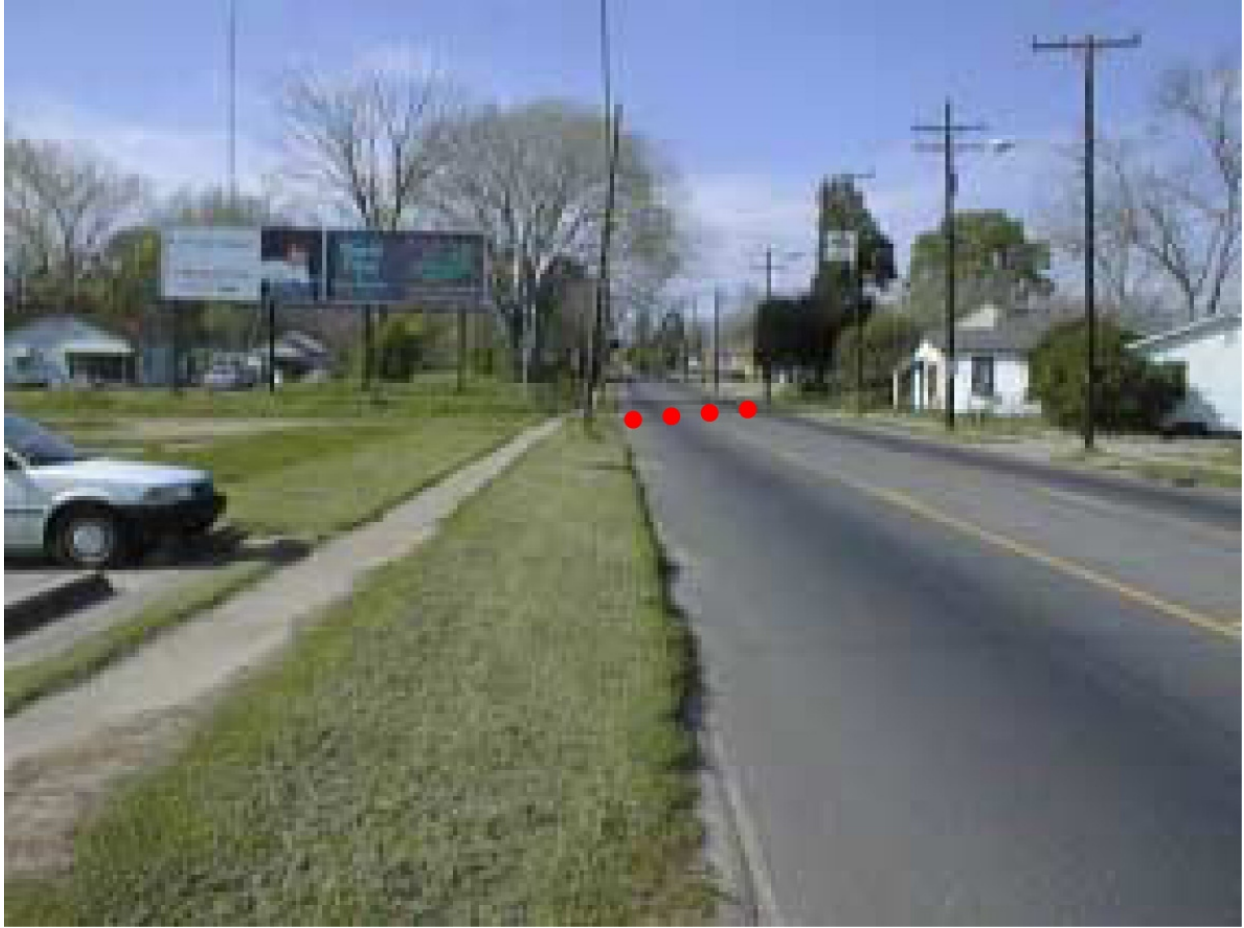
Figure 7. *Stop 3* photo (from McCulloh, 2001, Public Information Series No. 8, Figure 3); line of red dots marks approximate fault trace.

Stop 3. (Pleistocene/Holocene)—Highland Road north of LSU: the fault juxtaposes the Hammond (Pleistocene terrace) on its upthrown block with the Holocene Mississippi River backswamp deposit on its downthrown block, coinciding here (as at Stop 2) with the Pleistocene–Holocene terrace escarpment and contact.

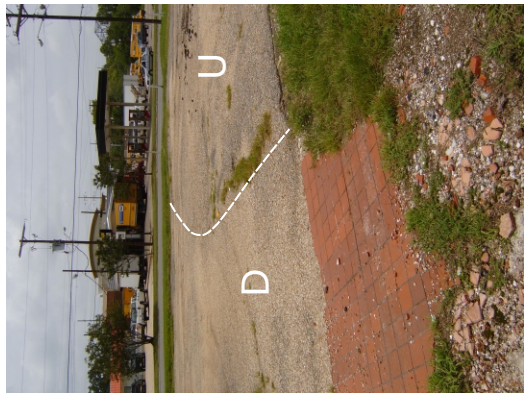
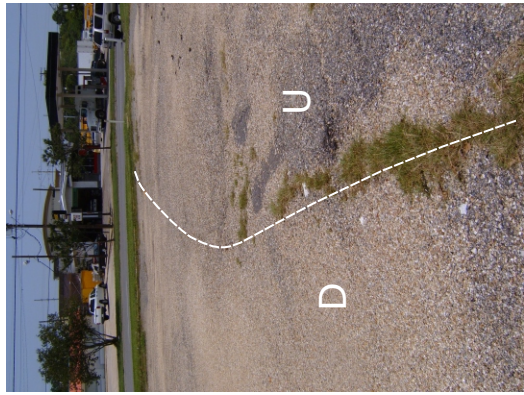
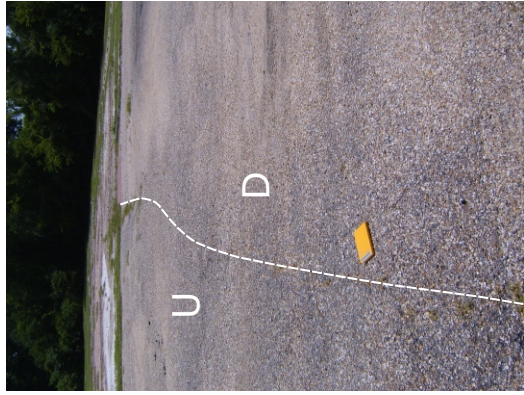
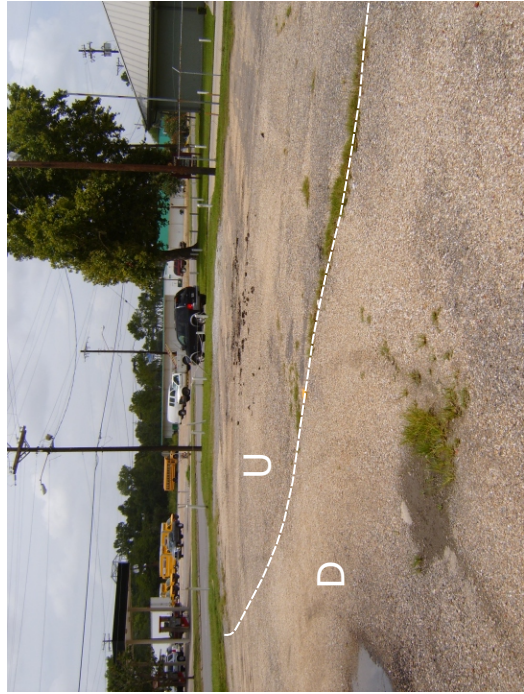
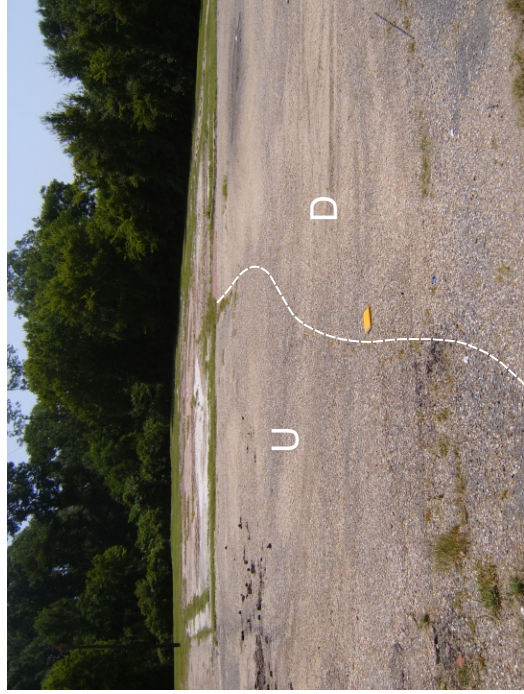
Figure 8. Photos taken at **Stop 4**; dashed line marks fault trace, U=upthrown block, D=downthrown block (field book measures 19 x 12 cm or 7.5 x 4.6 inches).

Stop 4. (Holocene/Holocene)—Nicholson Drive north of LSU (old Pancho’s restaurant lot, now empty except for remains of the foundation including some remaining tile): the fault displaces the Holocene Mississippi River backswamp deposit, and manifests in the parking-lot pavement as a monoclinial flexure with an apparent amplitude of approximately 10–25 cm (4–10 inches).

Figure 8 comprises photos taken at the Stop 4 locality and annotated to show the interpreted fault trace in the parking-lot pavement, in views looking west-northwest, northwest, and east-southeast.
